# Preparation of Hazard, Vulnerability & Risk Analysis atlas and report for the state of Himachal Pradesh

## Building Vulnerability and Risk Assessment Composite Final Draft Report (T6)

TARU Leading Edge Pvt. Ltd.  
New Delhi and Ahmedabad, India

March 2015

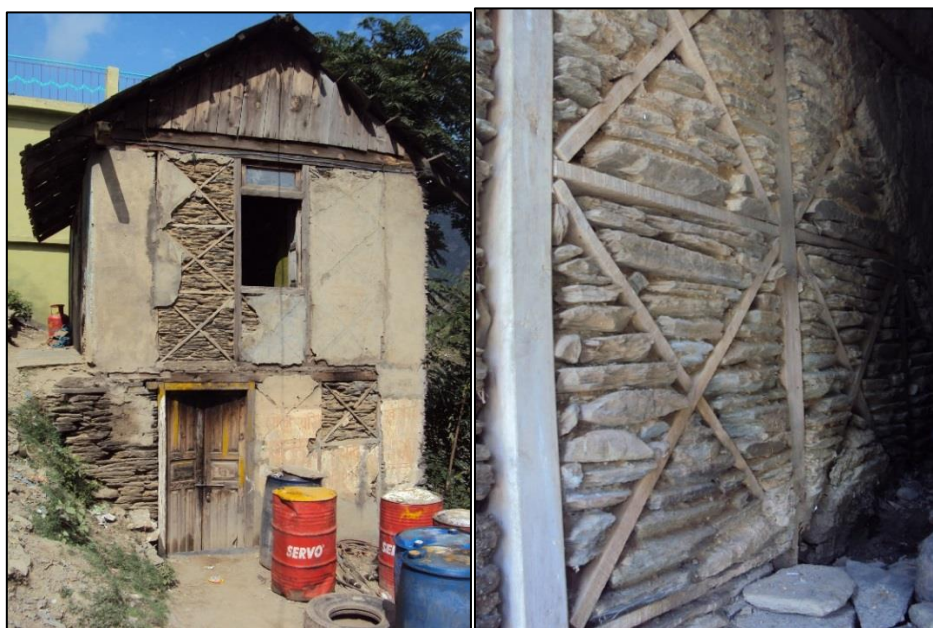
Dhajji Dewari is a traditional construction type mainly found in Shimla and Kangra district of Himachal Pradesh. In Indian standard code, it is termed as brick naged timber frame construction. In this construction technique, timber frame is used as bracing and space between frames is filled with brick or stone traditionally laid into mud mortar (Fig. 19). Completed walls are plastered with mud mortar.

Figure 19: Dhajji Dewari Type House (Shimla, 13<sup>th</sup> November 2013)

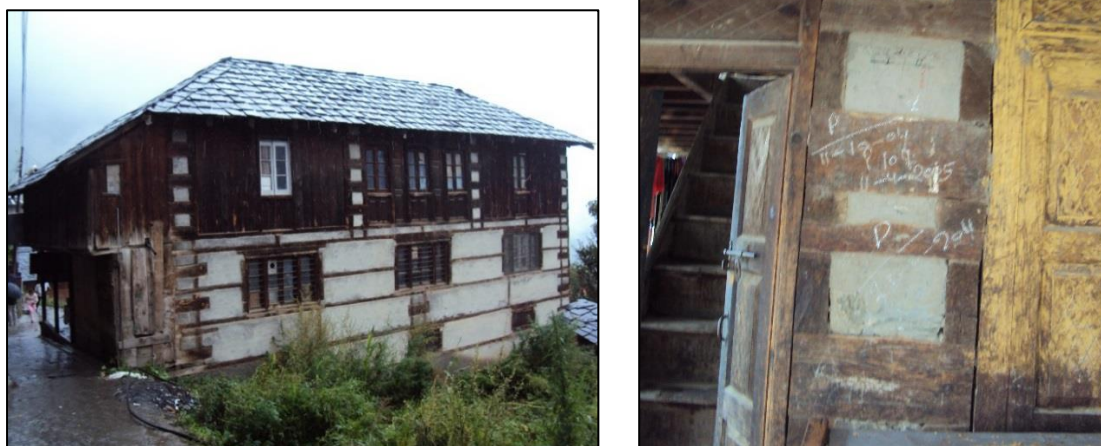
This building type is mostly found in Chamba district of Himachal Pradesh. Locally term “Thathara” is used for wooden planks and they are use as vertical load carrying members (Fig. 20). Thathara houses are mostly built in cold regions which witness heavy snowfall in winter season (October to March). These houses have sloping roofs with adequate projection to take care of snow deposition on roof. Mud and wood interiors keep the house warm.

Figure 20: Thathara House (Bharmour, Dist. Chamba, 20th October 2013)

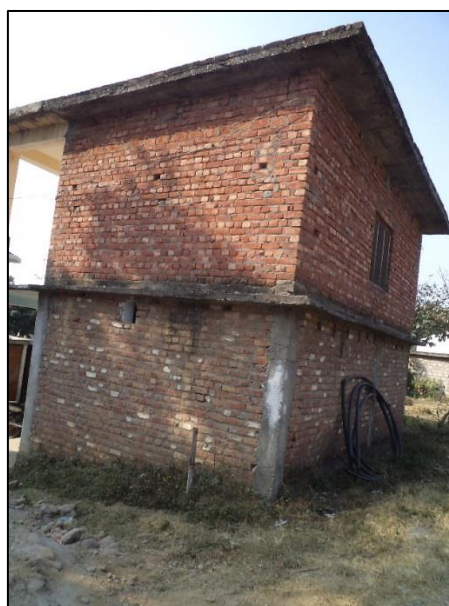
Hybrid construction is observed in many places. If two floors have been constructed of using different construction practice (Example: masonry and RC Frame), it is termed as hybrid construction (Fig. 24). Hybrid construction can proved to be disastrous for the building at the time of earthquake. Load path mechanism vary in hybrid construction. Example: If first floor is brick masonry construction and second floor is RC Frame construction then load transfer will occur from columns of second floor RC frame structure to the corner of load bearing walls of ground floor structure. Load concentration at the corner of the wall can lead to severe cracks in the building.

**Figure 24: Hybrid Construction (RC Frame and Brick Masonry) in Kangra**

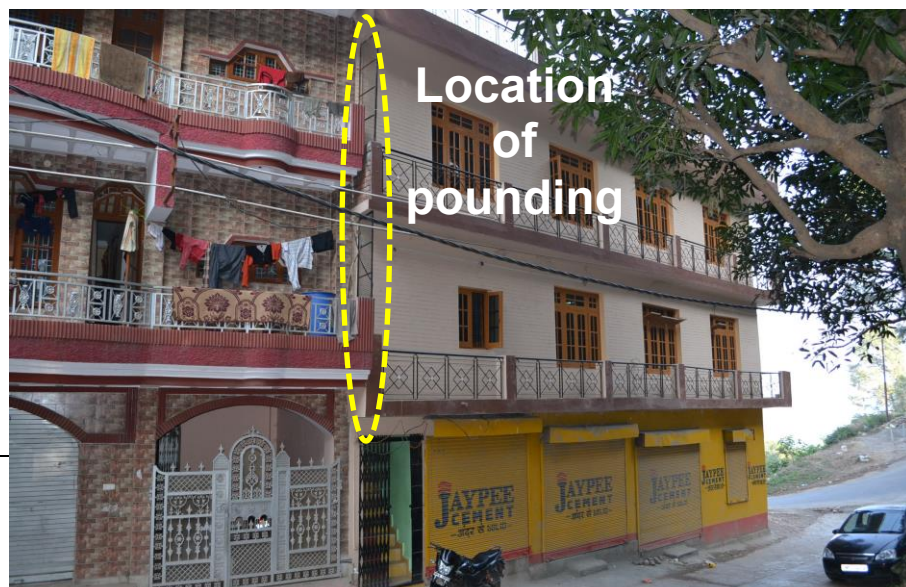
Pounding is the result of irregular response of adjacent buildings of different heights and of different dynamic characteristics. In situations where two buildings are located too close to each other, they may collide during strong shaking leading to substantial damage. The pounding effect is more pronounced in taller buildings (fig. 26). When building heights do not match, the roof of the shorter building may pound at the mid-height of the columns in the taller building; this can be quite dangerous, and can lead to story collapse.

**Figure 26: Possible location of occurrence of pounding**

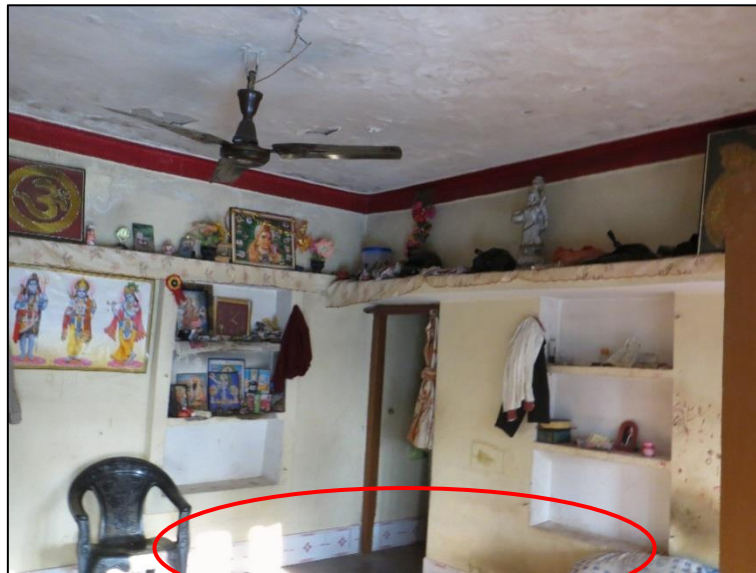
Water seepage was found in almost all the buildings. Water proofing treatment to roof should always be given as water seepage problem pose a serious threat to the buildings. Reinforcement of slab, beam and column get corroded due to water seepage which reduced the load carrying capacity of the building elements. Excessive corrosion also lead to vertical cracks in the longitudinal steel of the column and horizontal cracks in the beam.

**Figure 27: Water seepage problem in the roof and wall (Hamirpur, 16th December 2013)**

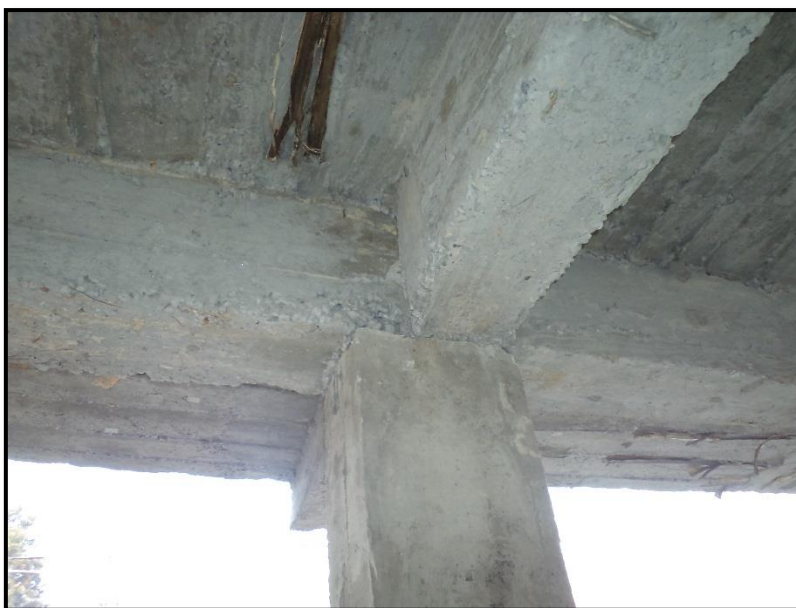
A very common problem at the junction of beam column was found in almost everywhere in the state. It was observed that centre line of beam and column were not passing through a same line (Fig. 28). Generally beam is provided offset to one direction of the column. This kind of beam column junction provide the eccentricity and it will create torsional forces. It was find out that masons provide this type of joint just to avoid extra shuttering which will be require to keep the load path for beam column at same line. This is bad construction practice and it should be avoided.

**Figure 28: Wrong Practice of Beam Column Junction**

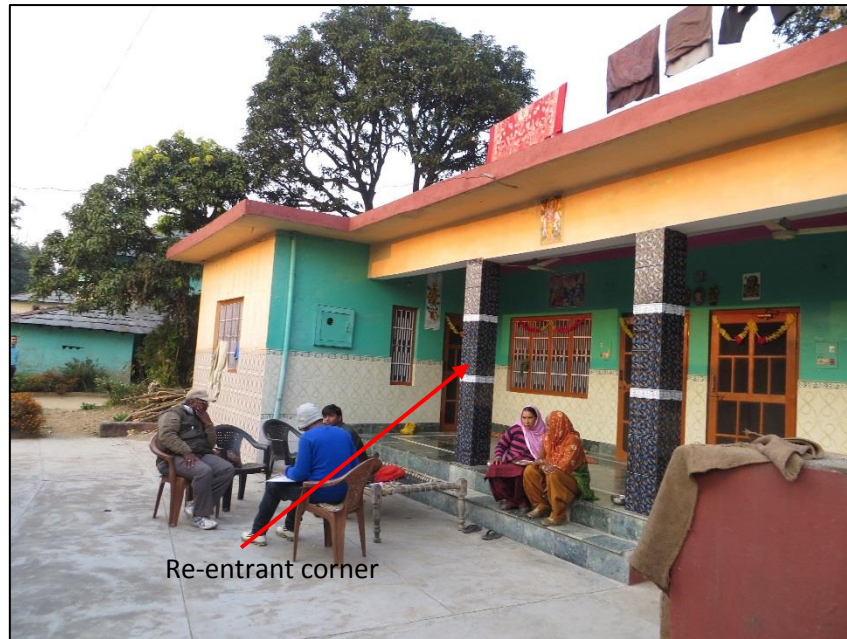
The dimension of the offset and the proportion of the derived wings will determine the vulnerability of a building. Each wing will react to the displacements and the torsional effects produced by ground motions in a different way. Under the action of earthquake forces, each wing will have a different dynamic behaviour because of its particular stiffness and position relative to the direction of horizontal forces. The movement of different parts of the building can be very complicated, producing considerable diaphragm deformation, torsional effects and concentration of stress at the vertices of re-entrant corners. Figure 29 shows the re-entrant corner present in the building.

**Figure 29: Re-entrant corner in L shape building (Kangra, 17th December 2013)**

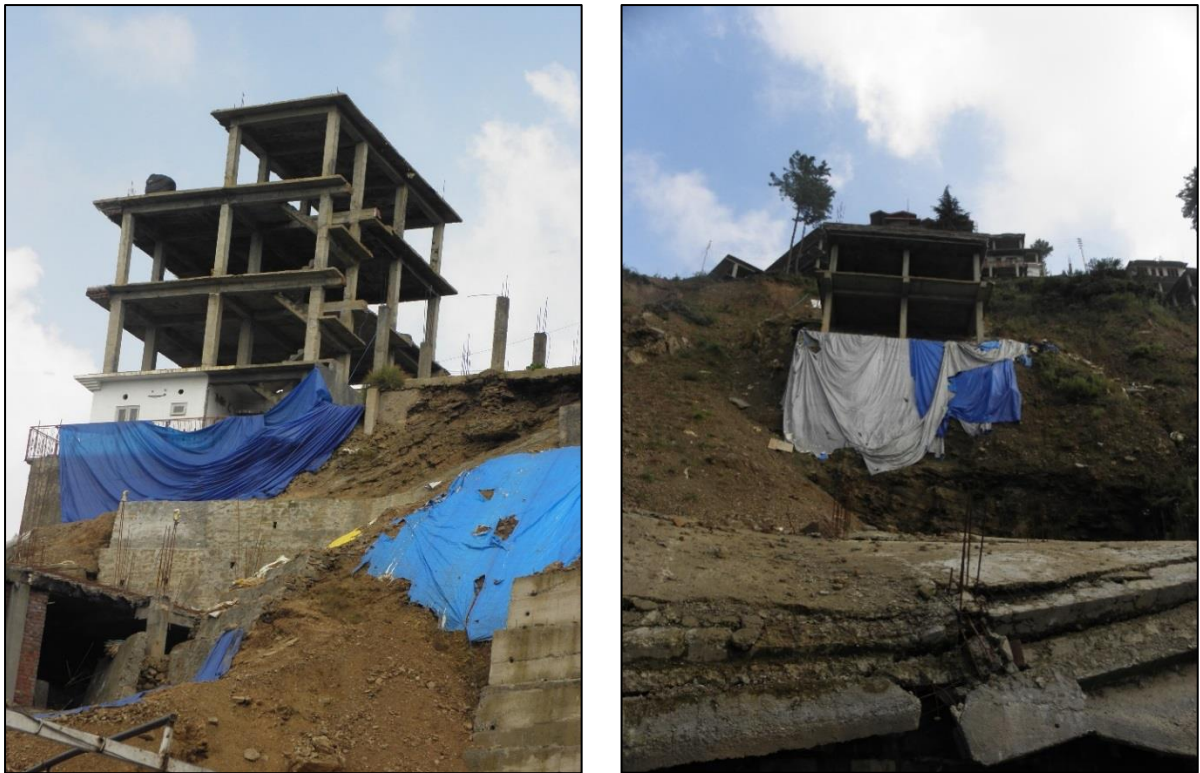
Site morphology plays a vital role in defining the vulnerability of buildings. As most of the building site is sloping ground, precautions need to be taken to stabilize the slope before construction of building. Retaining wall must be provided before construction in sloping site. For a stepback building construction, separate columns should be provided for different floors although same foundation can be given. For a building located on sloping site, column with unequal height in the ground storey should be avoided as shorter column being stiffer attract more horizontal forces and are liable to fail in shear.

**Figure 30: Construction of building on sloping site**

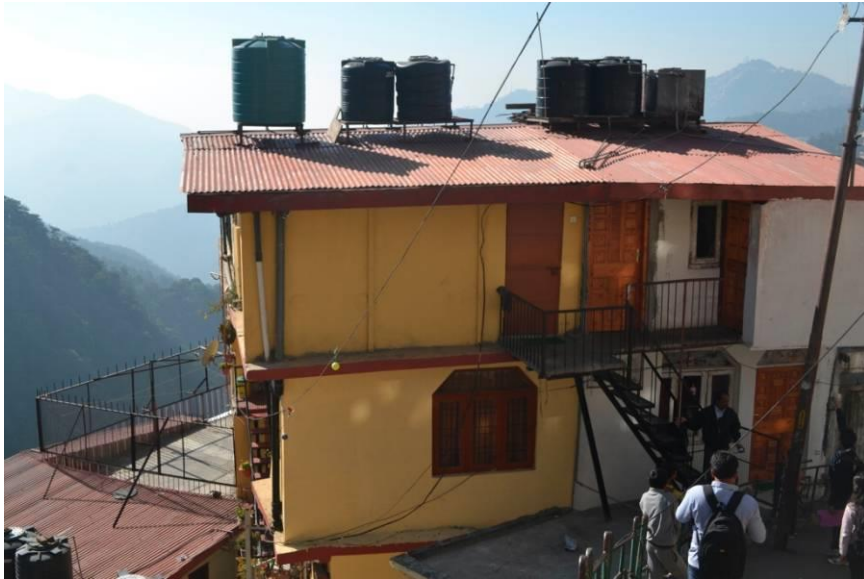
Heavy overhangs are formed when projections of the actual habitable spaces, from the first floor upwards, are made to increase the available floor area in the upper floor tenements. Buildings having such large and heavy cantilever projections have been observed to sustain heavy damage in earthquake events. Heavy balconies and overhanging floors in multistory reinforced concrete buildings shift the mass center upwards; accordingly give rise to increased seismic lateral forces and overturning moments during earthquakes. Heavy balconies and overhanging floors in reinforced concrete buildings shift the mass center upwards; accordingly increase seismic lateral forces and overturning moments during earthquakes. Buildings having balconies with large overhanging cantilever spans enclosed with heavy concrete parapets sustained heavier damages during the earthquakes compared to regular buildings in elevation. Since this building feature can easily be observed during a walk-down survey, it is included in the parameter set. Large cantilevers (projections supported only on one side) especially at upper floors are undesirable. Figure 39 shows presence of heavy overhangs on the top of building.

**Figure 39: Heavy overhangs are present on the top of structure at Kangra district**

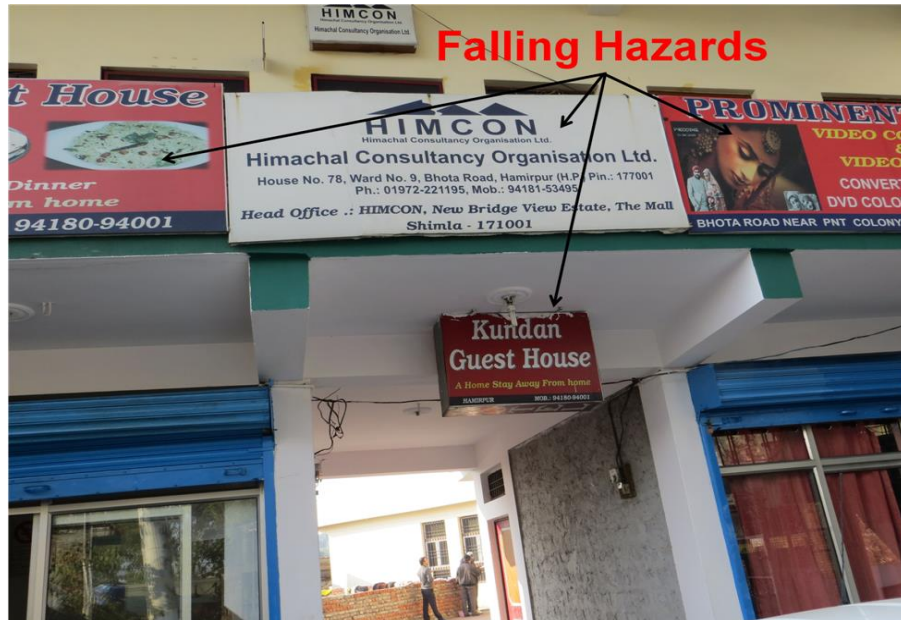
Falling hazards include mechanical and electrical equipment, piping and ducting, unsecured masonry parapets, and eccentrically placed water tanks on top of the building. A slab or a beam supported only on one side and projecting horizontally on the other side is called a 'Cantilever' slab or beam e.g. balconies, lofts and canopies. Figure 41 shows location of falling hazards in a building.

**Figure 41: Falling hazards in a building**

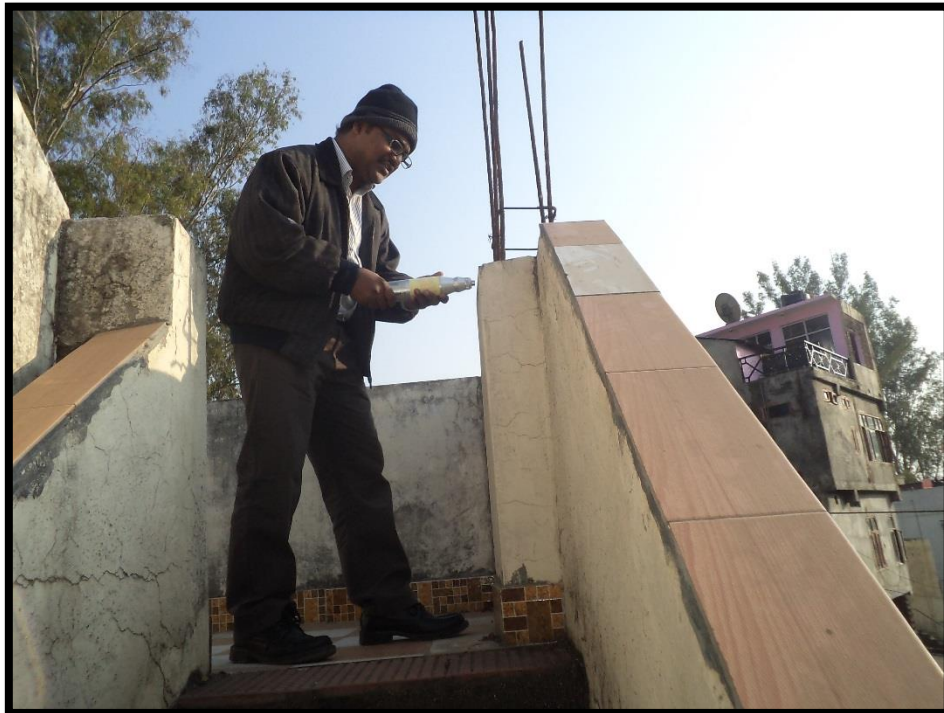
**Figure 73: Rebound Hammer Test (Hamirpur, 15th December 2013)**
